## **FAIRFIELD FACILITIES ASSESSMENT**

200 Main Street, Meeker, CO 81641

Prepared By

**ROSENFELD DESIGN**

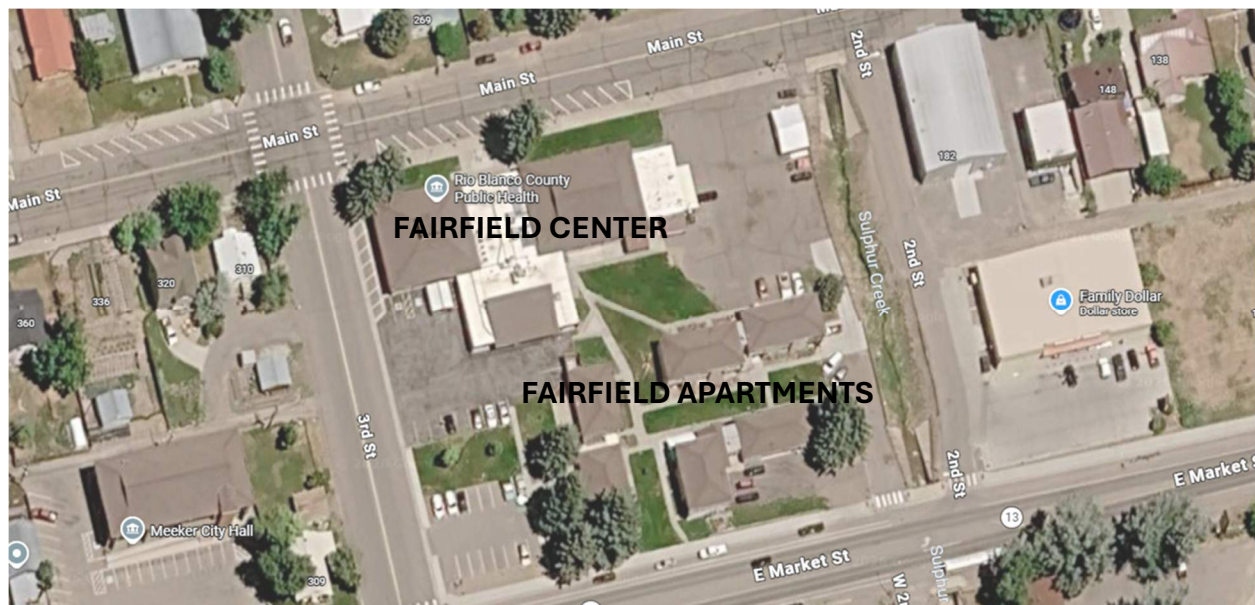
Existing subgrade utilities and infrastructure are a combination of shared and independent services for the facilities. Per the 2014 Plat and Civil drawings provided by SGM, it is anticipated that water, electric and communications services are shared between the Fairfield Center and Apartments. Sewer and natural gas services are understood to be independent to each facility. Electrical service for the entire property is fed to the Fairfield Apartments and branches to the Fairfield Center. Domestic water service for the property is located at the Fairfield Center and then branches to the Apartments.

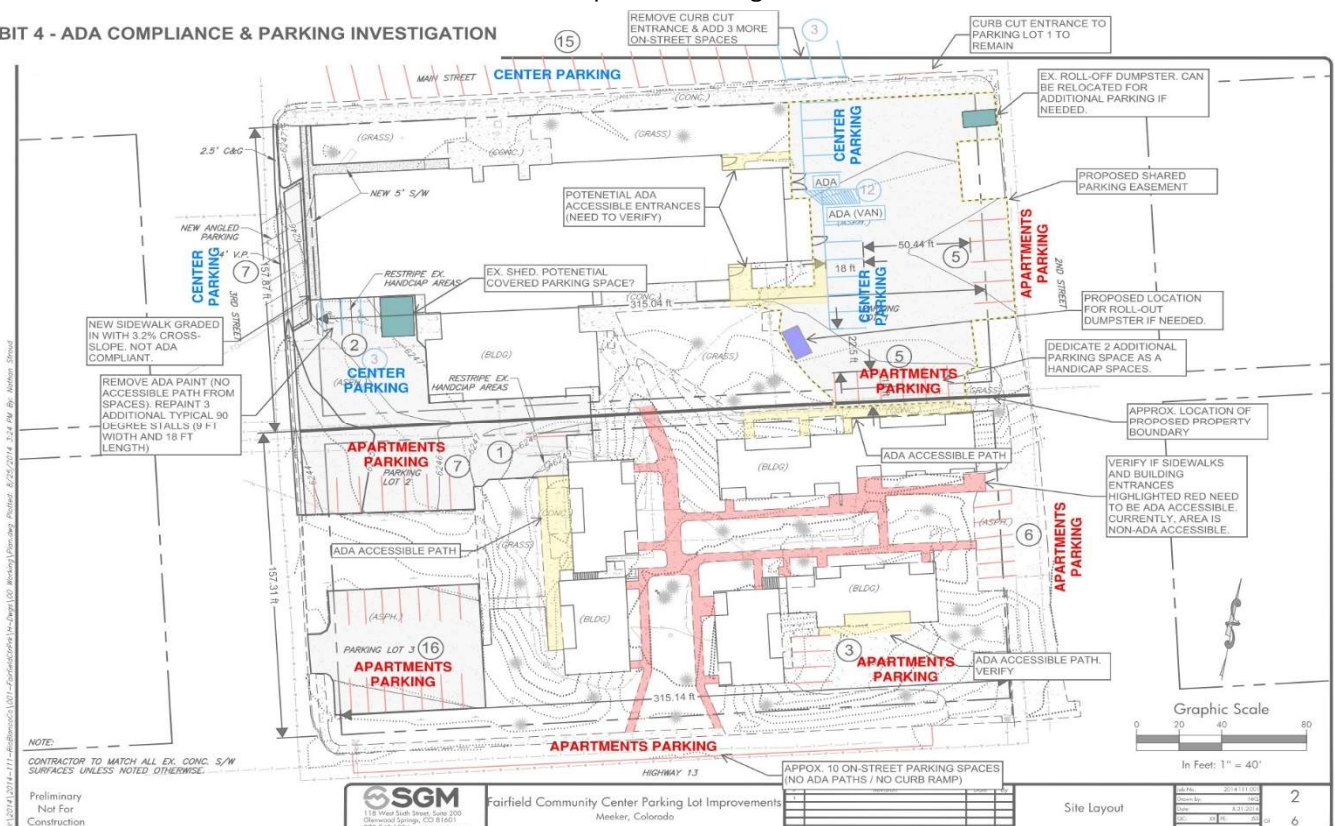
EXHIBIT 4 - ADA COMPLIANCE & PARKING INVESTIGATION

5. ADA accessible routes are assumed to be present along the eastern face of the Community Center leading towards the two Community Room entrances. The two Community Room entrances need to be verified to determine if it's an allowable public building entrance.

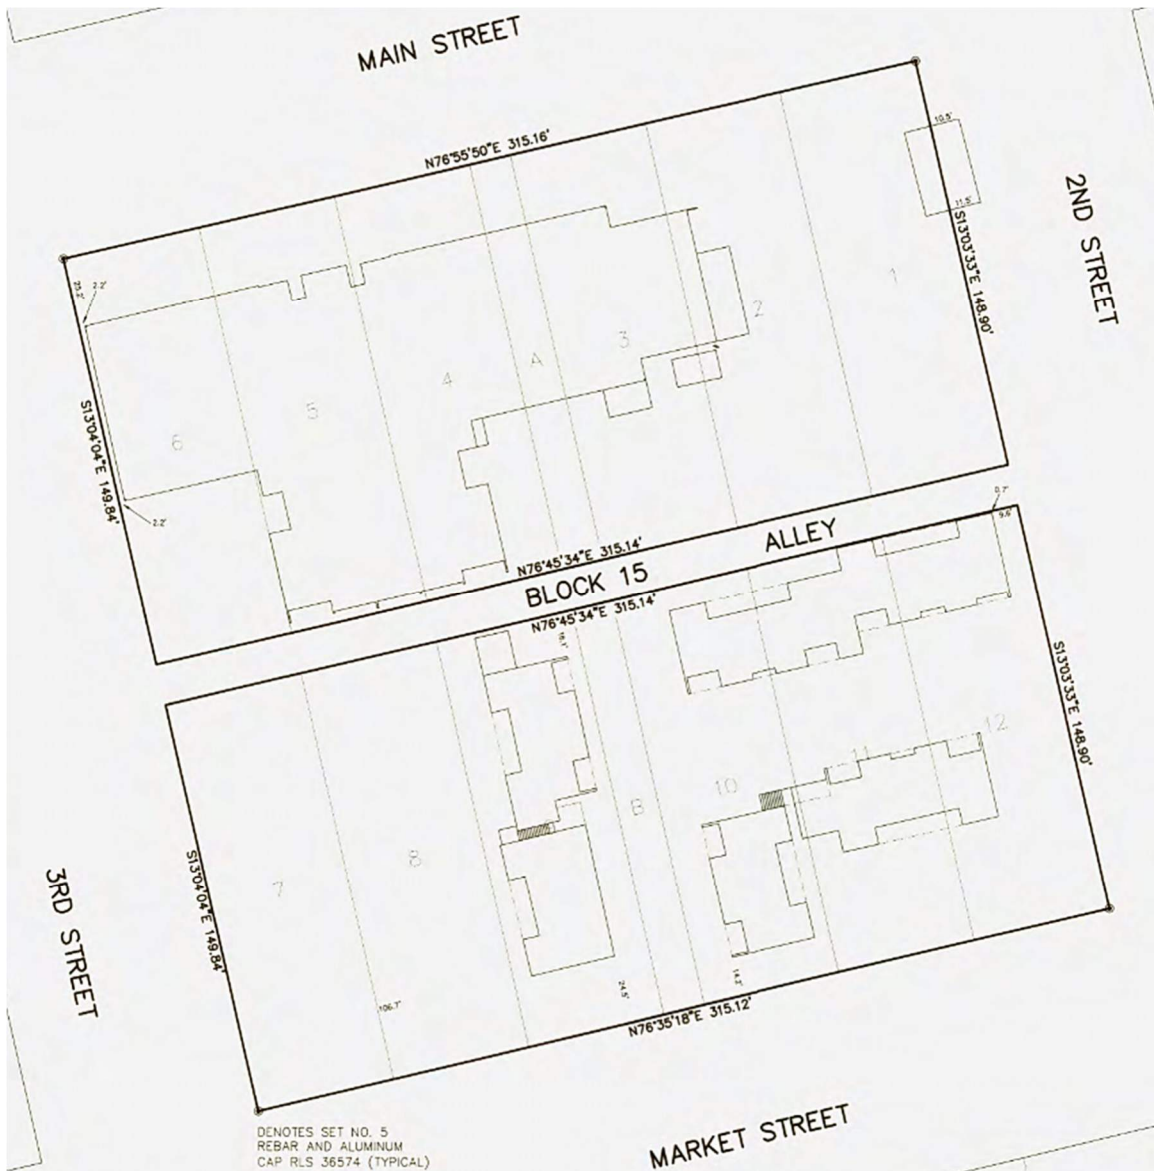
**PROPERTY BOUNDARIES AS DEFINED BY 2014 JSC, INC. IMPROVEMENT SURVEY PLAT**

Based on discussions with the Town of Meeker Community Development Department, the current Plat below clearly identifies the two parcels under consideration. Therefore, no additional Planning review is anticipated should Rio Blanco County decide to divest either. The assumed existing utility easement at the Block 15 Alley will need to be verified and remain in place. Additionally, there will be an administrative procedure to address the southern parcel to Market Street.
